## Phase I Environmental Site Assessment

Approximate 22-Acre Site  
North of Lowes Drive & Marlandwood Road  
Temple, Texas 76502

August 3, 2021

PSI Project Number: 0435-4967

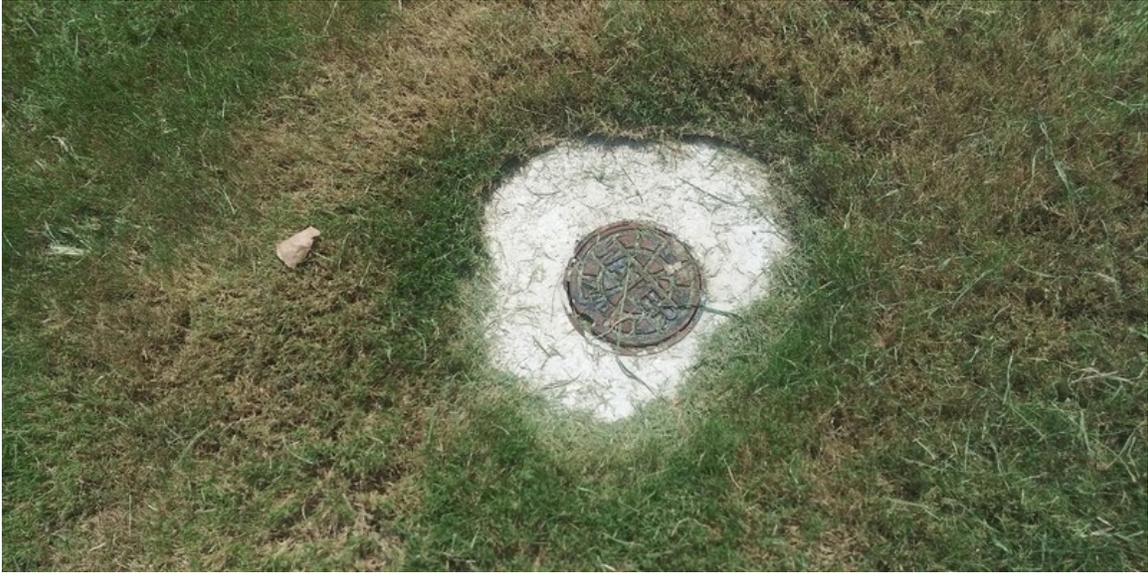
Photo 1: View of a city water line on the subject property.

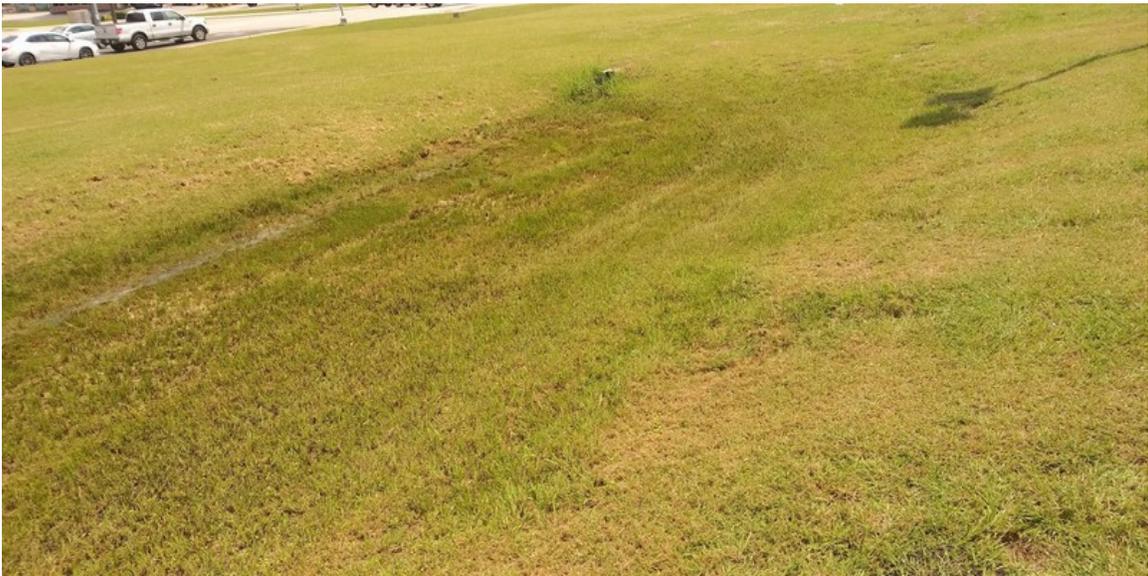
PSI observed an unimproved drainage ditch along the northwest to central portions of the subject property boundary. PSI did not observe evidence of standing water, staining or stressed vegetation in the vicinity of the ditch at the time of the site reconnaissance. The presence of this drainage ditch is not considered to be evidence of a REC in connection with the subject property.

Photo 8: View of a drainage ditch to the east of the south adjoining Sears Store.

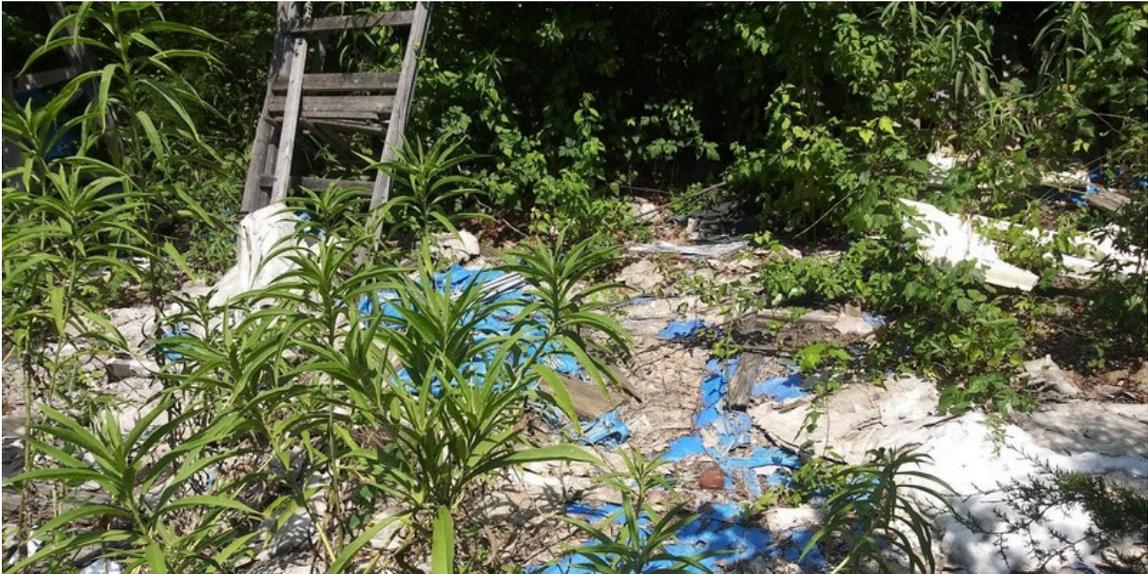
PSI identified areas of minor surface dumping of apparent construction materials - wood ladder, nylon tarp, tires, and sand bags - on the southwest portion of the subject property to the north of the Sears Store and on the 4-acre tract to the west of Lowes Drive. Additionally, sparse paper and plastic debris was occasionally noted scattered throughout the subject property. No staining, hazardous substances, or petroleum products were observed in the vicinity of the debris. PSI considers the presence of the minor surface dumping of non-hazardous materials to be a de minimis condition and, by definition, not a REC in connection with the subject property.

Photo 10: View of surface dumping on the southwest portion of the subject property north of the Sears Store.

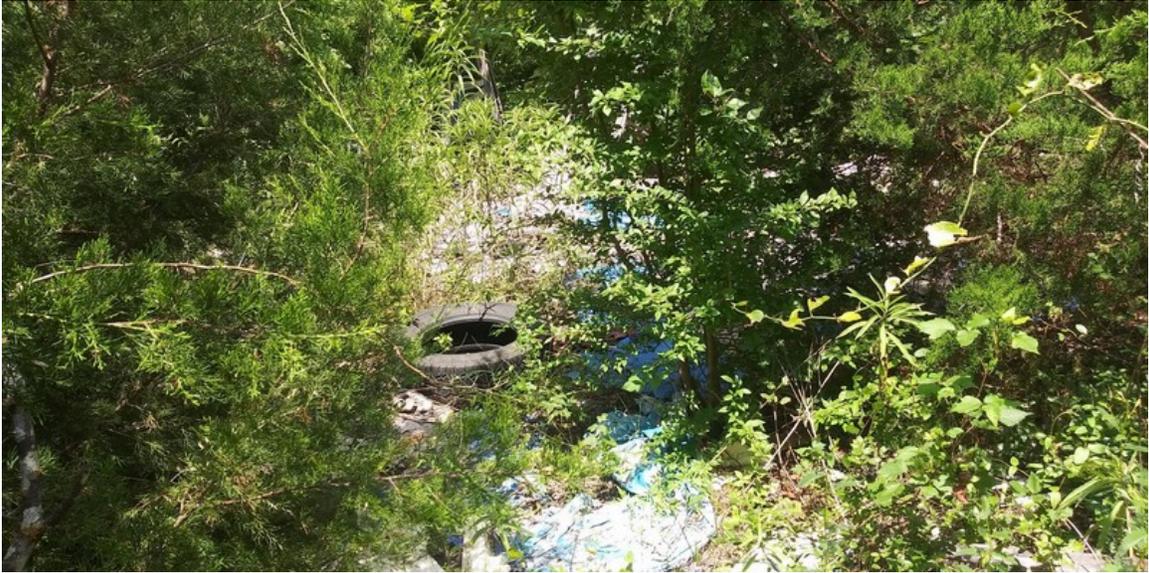
Photo 11: View of surface dumping on the southwest portion of the subject property north of the Sears Store.

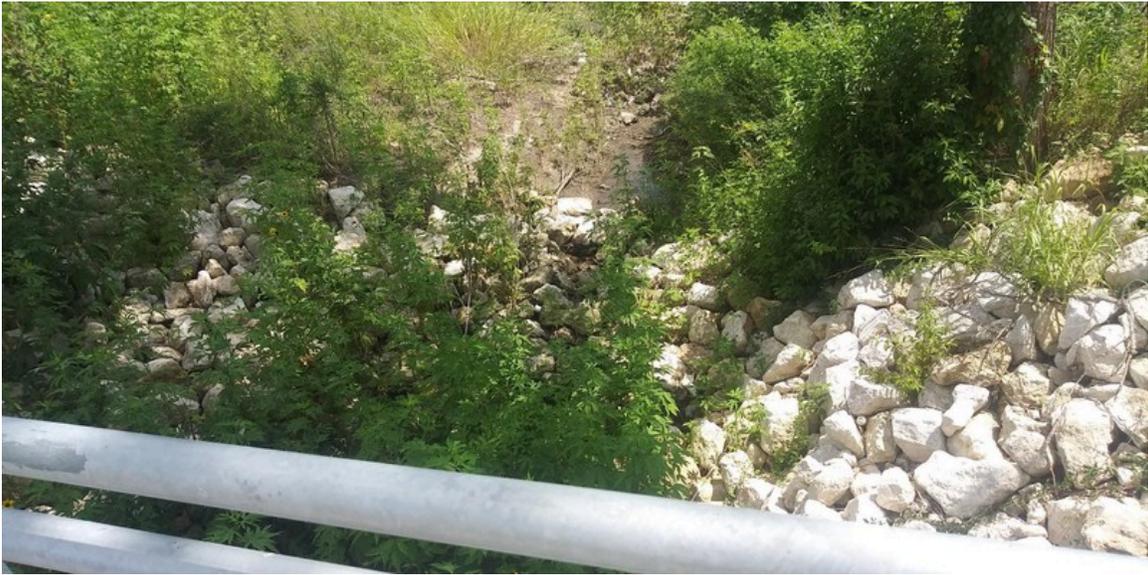
Photo 15: View of the drainage easement and underpass that goes under Azalea Drive near the northwest corner of the subject property.
